1 National Transportation Safety Board

5
6
7
8 Group Chairman's Factual Report

9
10
11
12
13 Survival Factors Group
14
15
16
17
18

19 *El Faro*

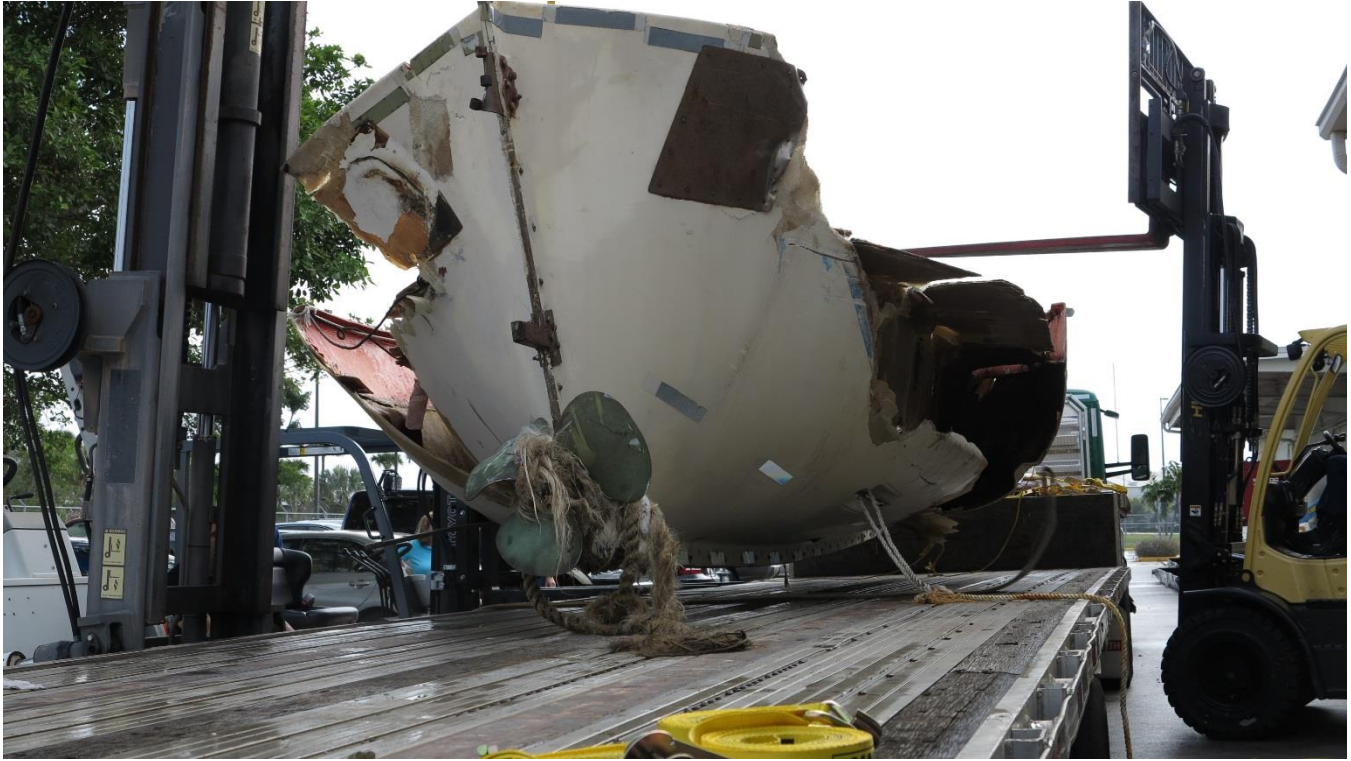
14 The starboard lifeboat was discovered during the SAR operation at 1500 on October 4 at
15 23°24.2'N, 073°54.5'W. The boat was swamped, floating bow up (figure 16). The lifeboat was too big for
16 the tug *Hawk* to recover, so TOTE chartered the offshore support vessel *Megan Beyel* to salvage the boat
17 and deliver it to the Port of Miami. The lifeboat was brought to Coast Guard Air Station Miami and
18 inspected (figure 17). Damage is noted in Table 5, below. Figure 18 shows the starboard lifeboat in its
19 davit before the accident.

2 **Figure 17.** *El Faro*'s starboard lifeboat as it arrived at Coast Guard Air Station Miami. Note fouled
3 propeller, bent propeller blade, and damage to port and starboard sides of the hull.

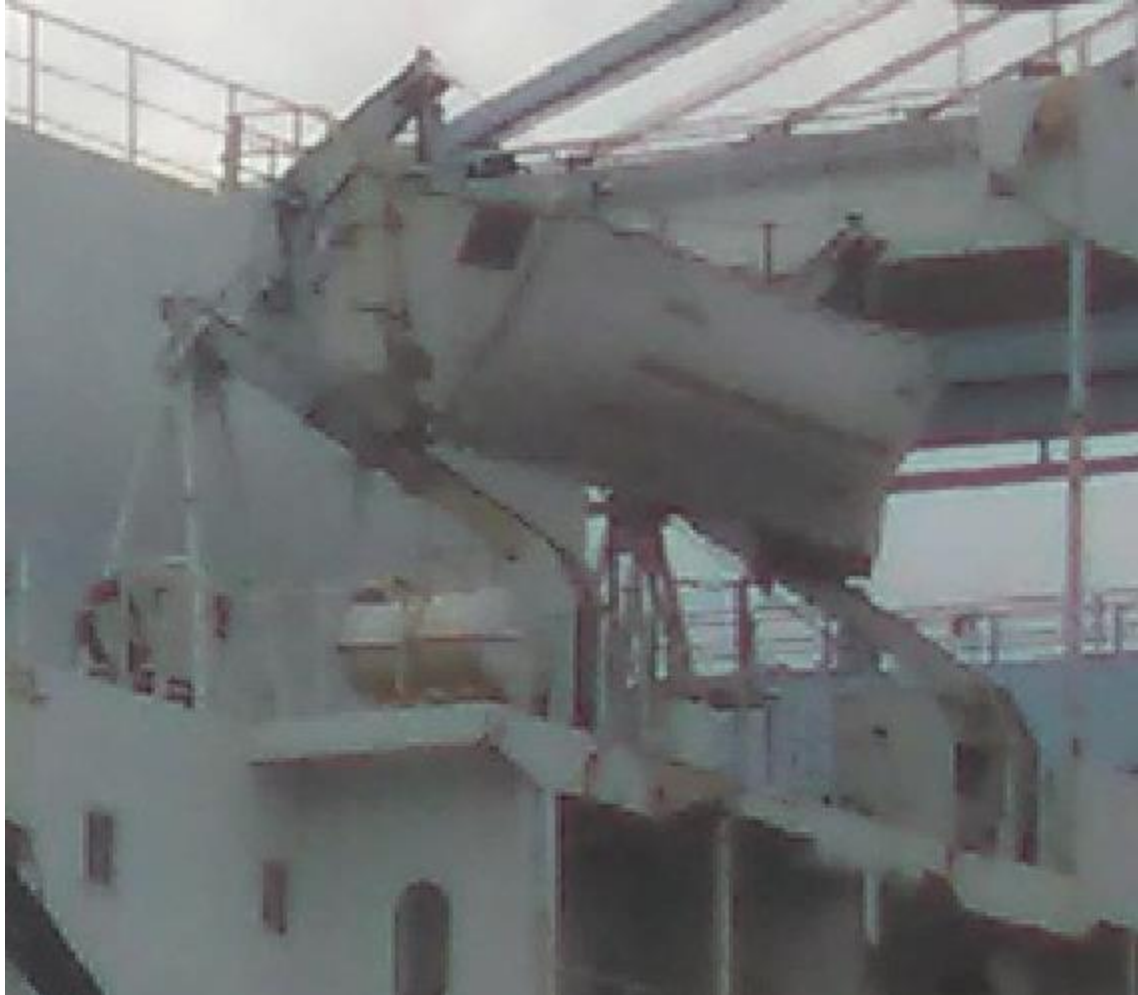
Figure 18. Photo taken before accident of *El Faro*'s starboard lifeboat stowed in gravity davits. (Photo by *El Faro* deck cadet)

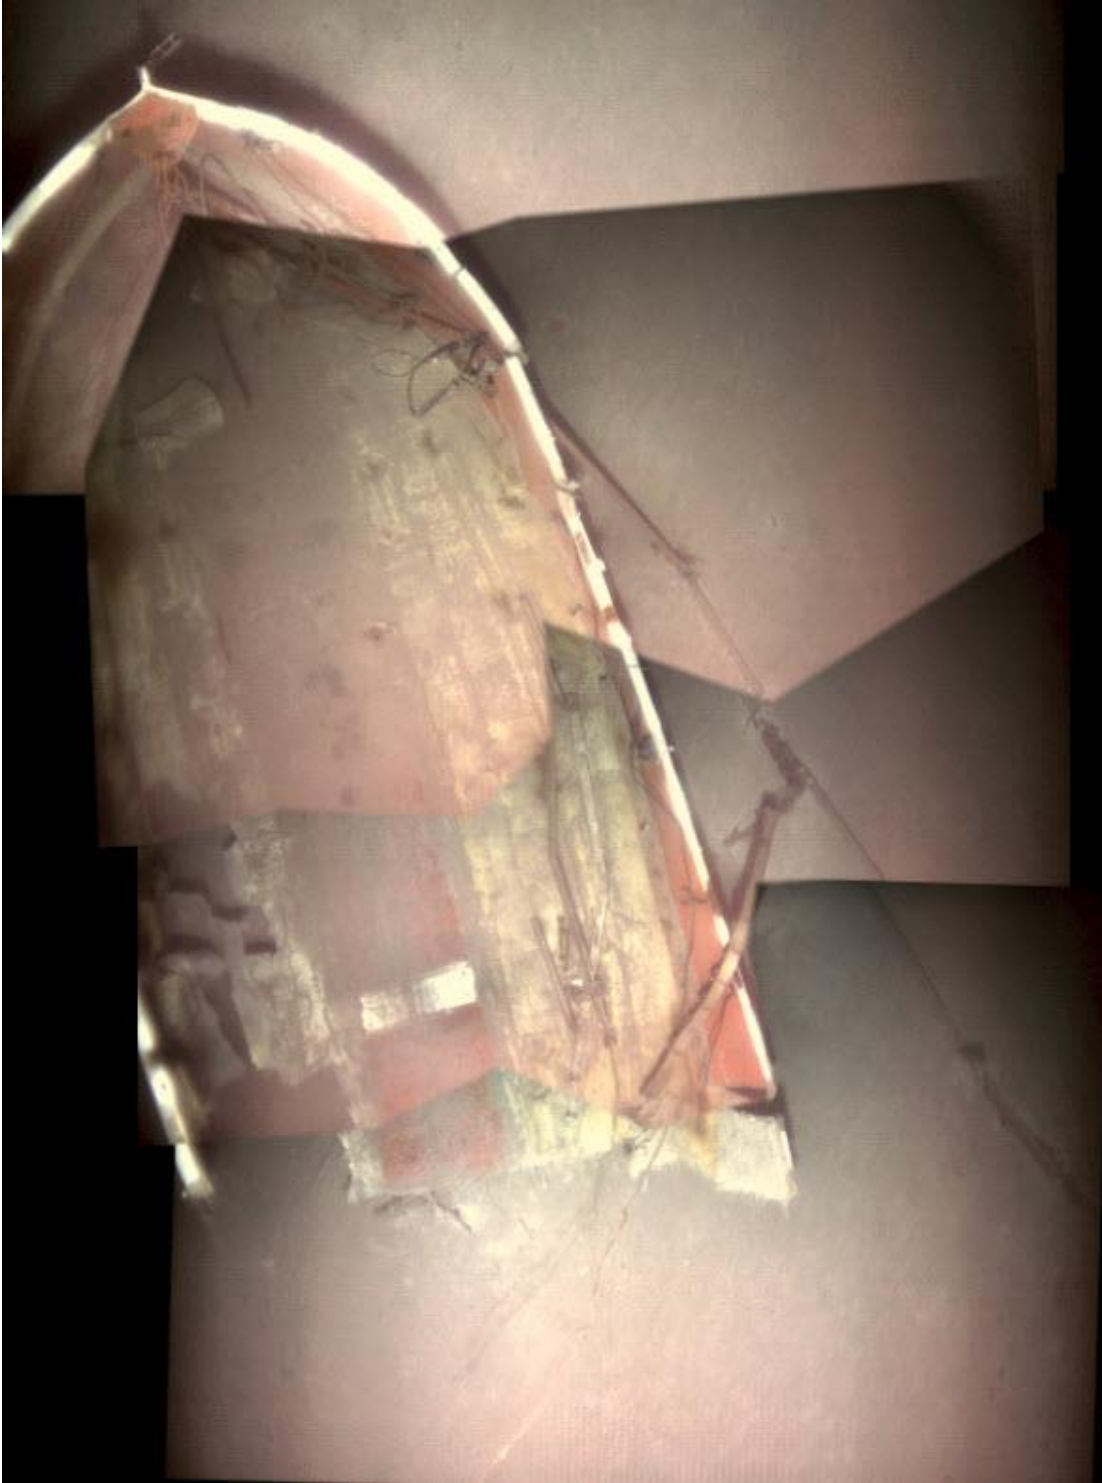
1 northeast of the midships section of *El Faro*'s hull. The major damage noted was that a portion of one end
2 of the lifeboat had been cut off (it was not found). See figures 20, 21, and 22 for photos related to *El*
3 *Faro*'s lifeboats taken during underwater VDR search. More information about the search for *El Faro*'s
4 VDR will be found in the factual report produced by the investigation's Electronic Data Group.

Figure 20. Photo mosaic of *El Faro*'s port lifeboat discovered by downlooking camera during underwater search by Woods Hole Oceanographic Institute vessel *Atlantis*, April 2016.

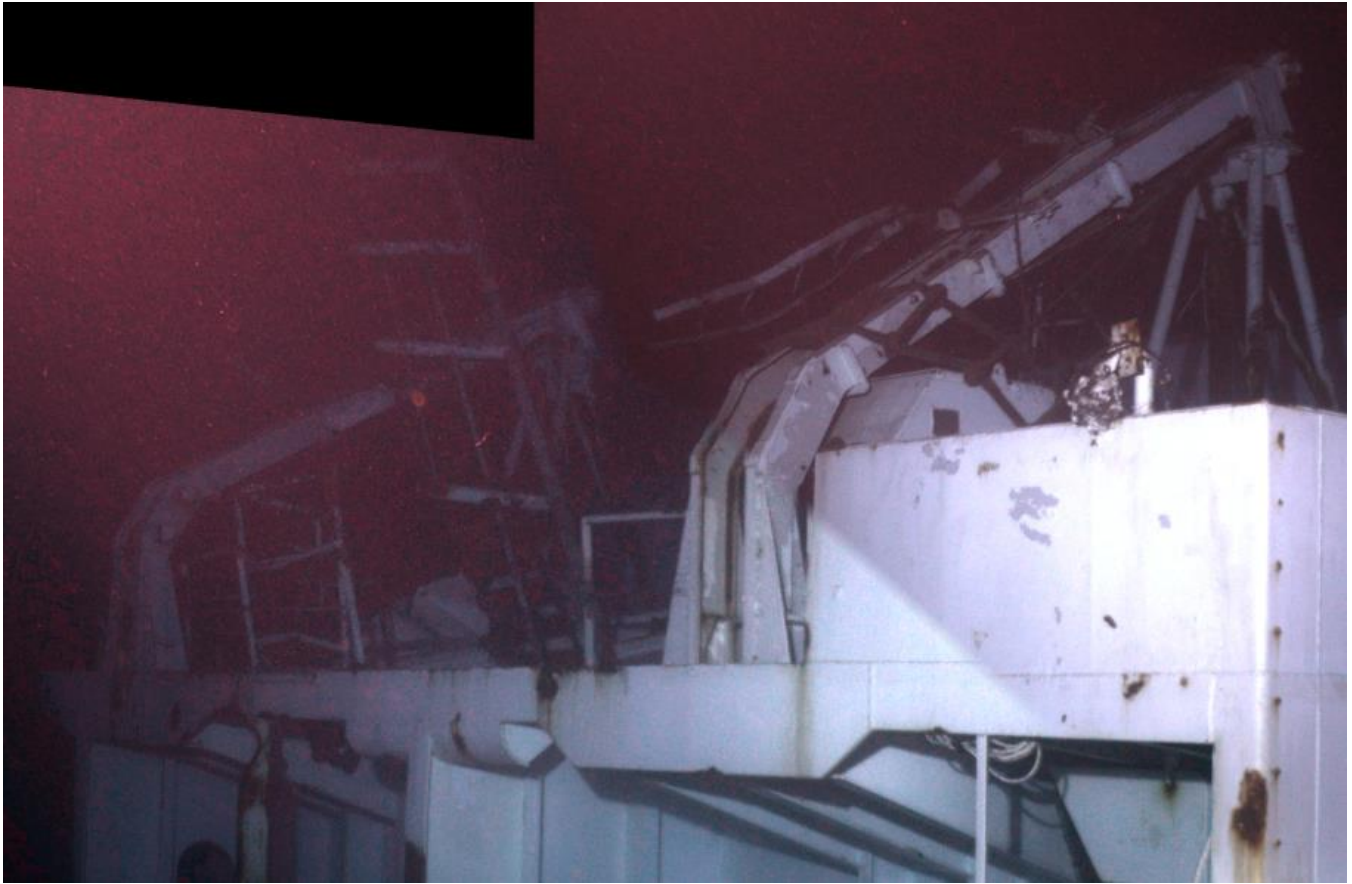
3 **Figure 21.** Photo mosaic of starboard lifeboat's "intact" gravity davits from camera flyover on second *EI*
4 *Faro* VDR search voyage by vessel *Atlantis*, April 2016.

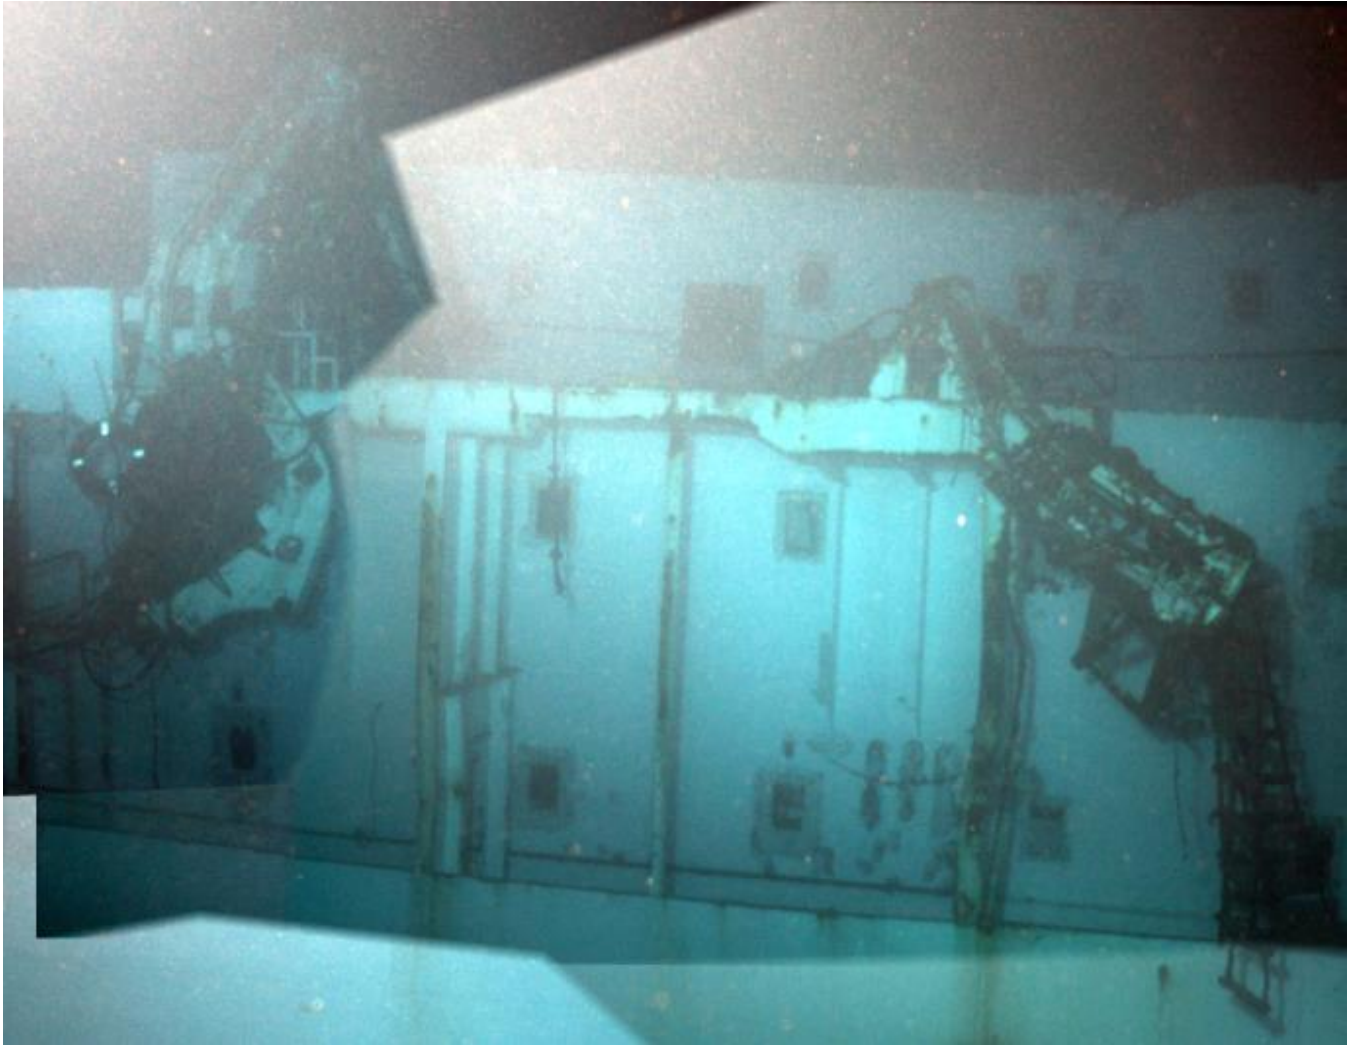
2 **Figure 22.** Photo mosaic of port lifeboat's "broken" gravity davits from camera flyover on second *El Faro*
3 VDR search voyage by vessel *Atlantis*, April 2016.

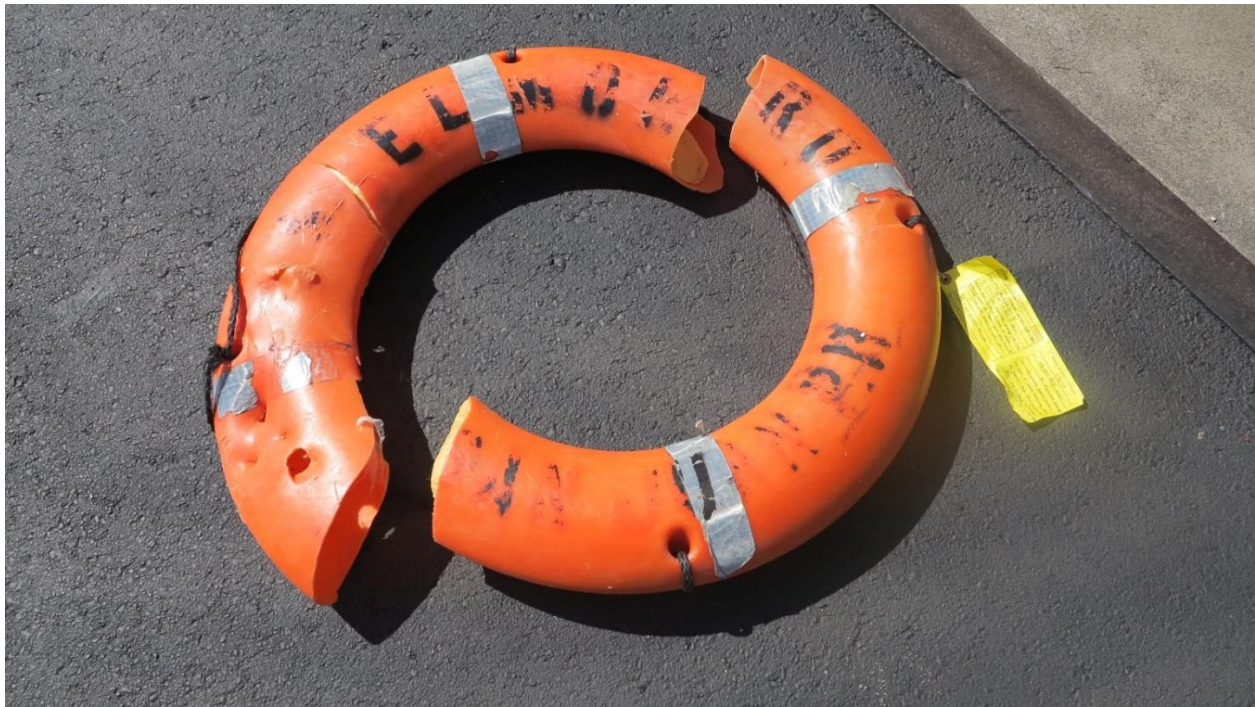
Figure 26. Recovered broken 30-inch lifebuoy stenciled *El Morro*, photographed in San Juan.

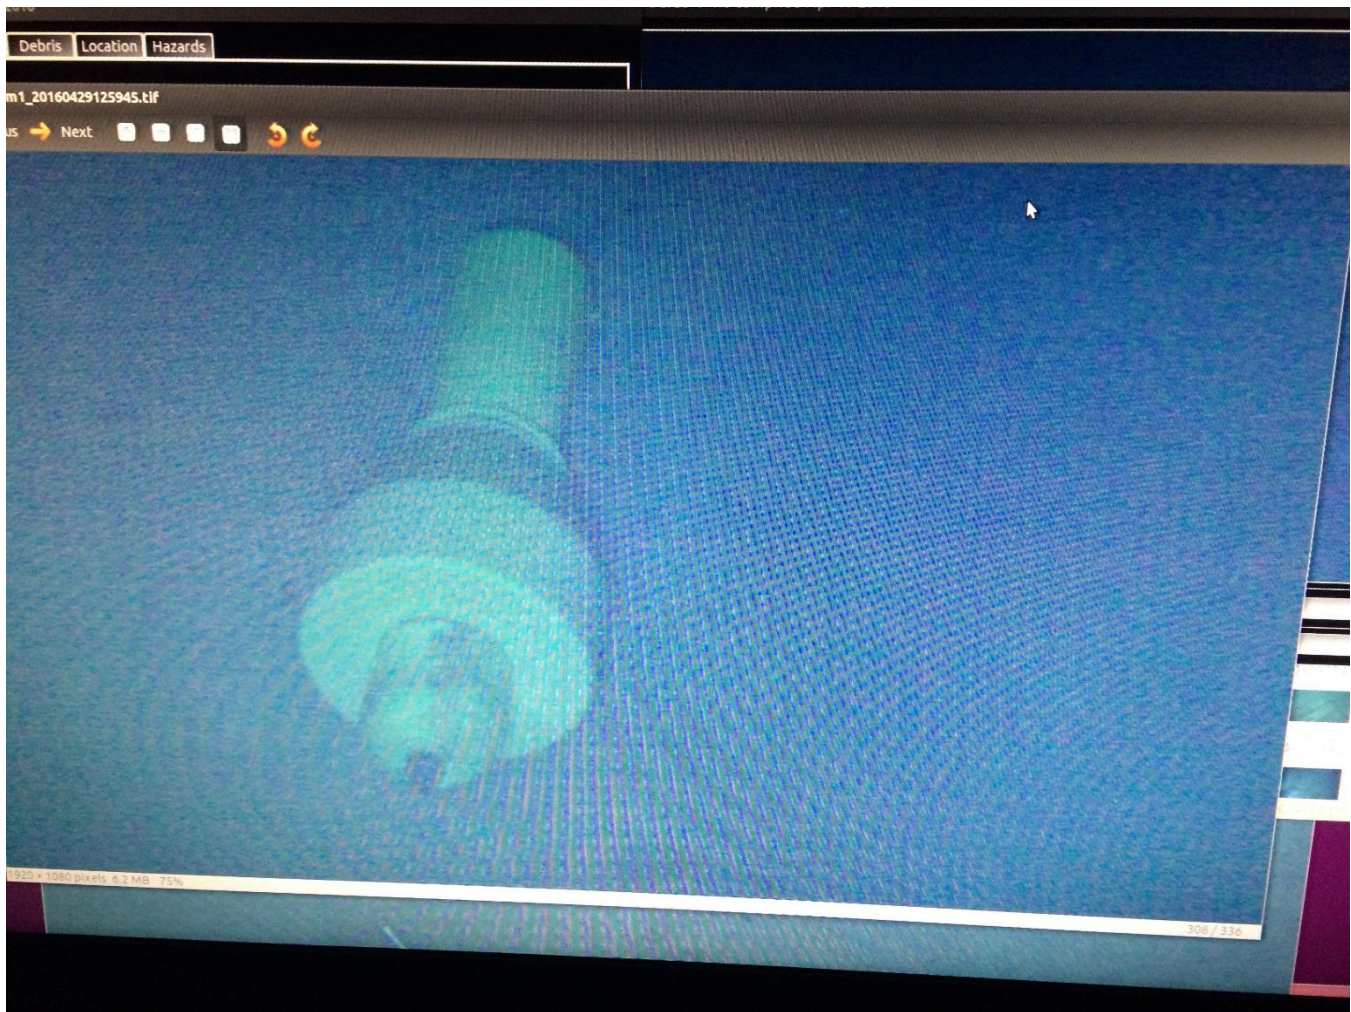
Figure 27. Smoke float on ocean floor found on second *El Faro* VDR search by vessel *Atlantis* in April 2016. TOTE's fire and safety plan shows lifebuoys and smoke floats on port and starboard bridge wings.

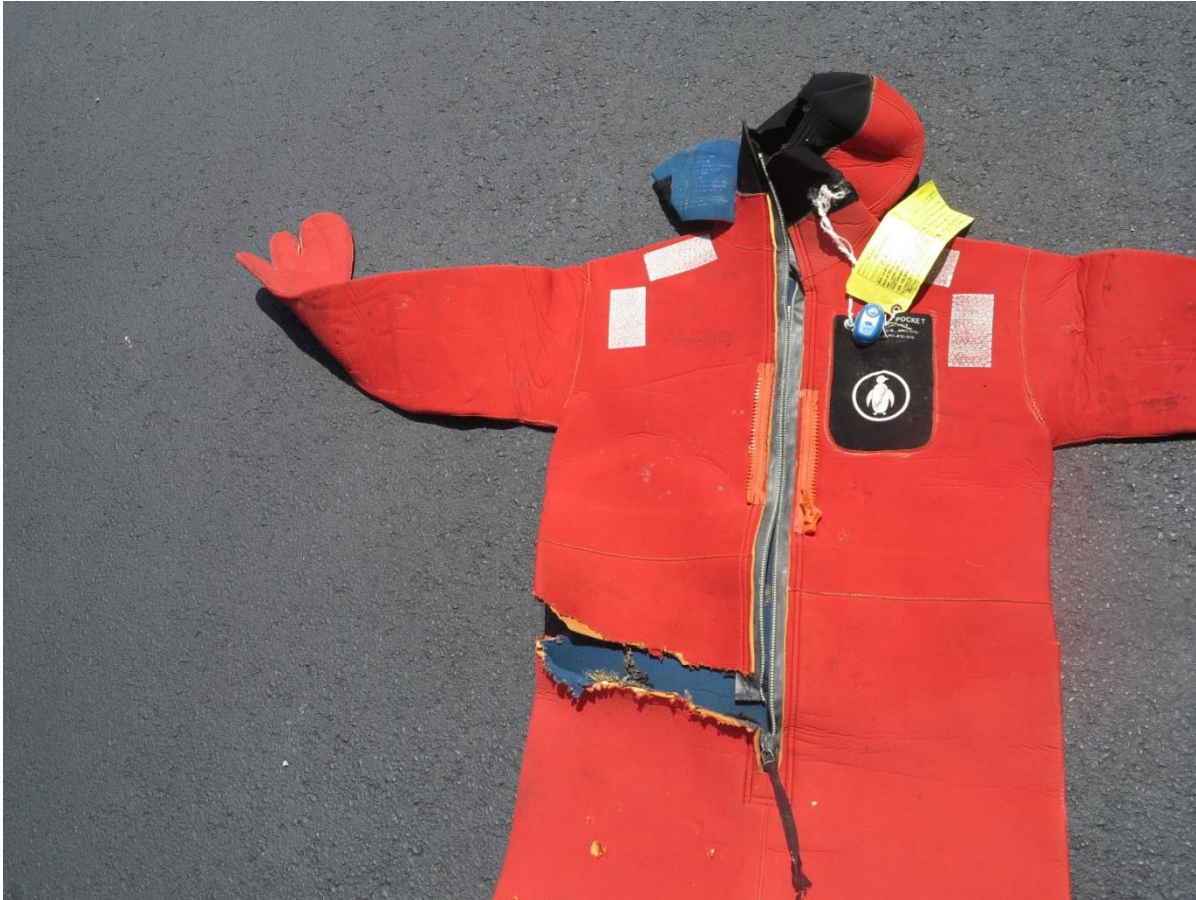
5 The second immersion suit was recovered on October 7 by the *Charles Sexton* (figure 28). It was
6 found with whistle and strobe light (off and operational); unzipped, left arm inside out, tear at right hip
7 seam almost in half; back marked "S.S. El Faro San Juan, P.R." in white and appears to have been
8 previously marked "El Morro" in black. It was labeled "Imperial Manufacturing Co., Bremerton, WA
9 98310; Adult Universal (more than 110 lbs.); Model No. 1409; Serial No. 95015; Lot No. 351/6;
10 Manufacture date 6-85."

2 **Figure 28.** Immersion suit found with whistle and strobe light (off and operational); unzipped, left arm
3 inside out, tear at right hip seam almost in half; back marked "S.S. El Faro San Juan, P.R." in white
4 appears to have been previously marked "El Morro" in black.
